**TEST REPORT**

**Report No.:** E9891.01-501-47

**PRODUCT TYPE:** Wall Panel System  
**SERIES/MODEL:** Vulkem® 116 Illmod 600® Acrytec Panel

**SPECIFICATION:** ASTM E 330, *Standard Test Method for Structural Performance of Exterior Windows, Doors, Skylights and Curtain Walls by Uniform Static Air Pressure Difference.*

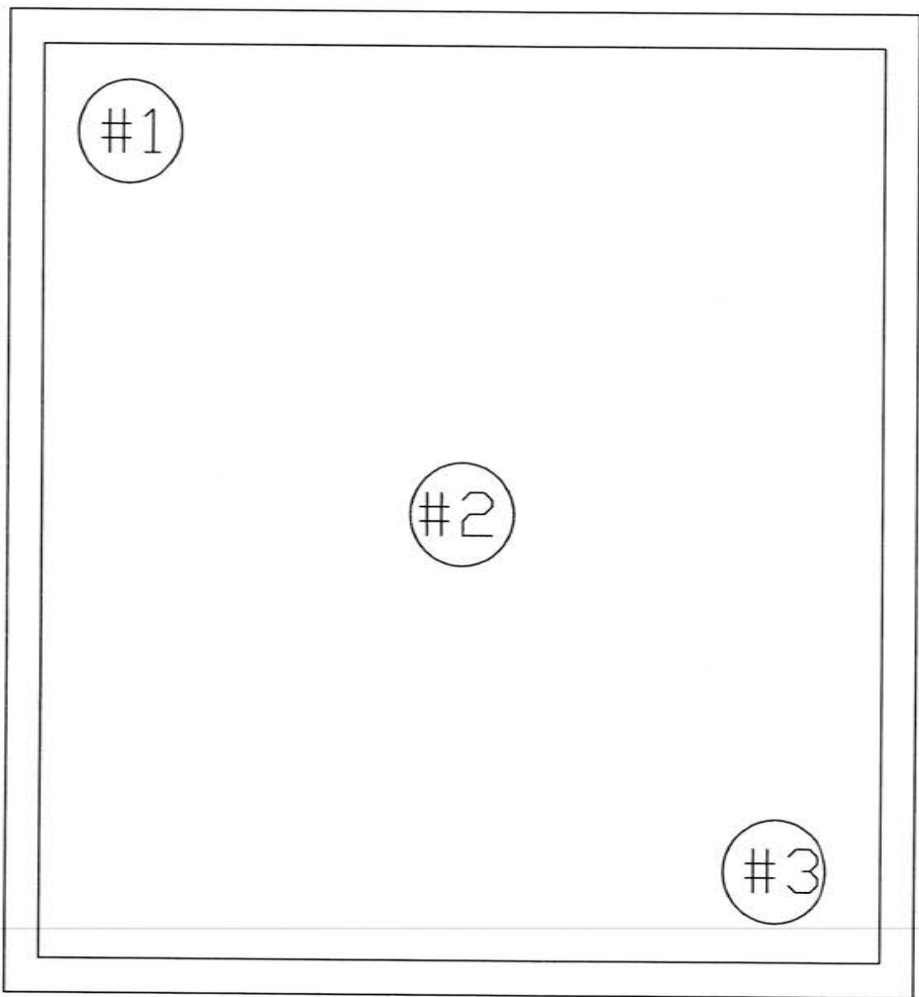
INDICATOR LOCATIONS

DRAWING  
(Indicators)

Title of Test	Test Pressure	Test Results (inch)		
		#1	#2	#3
<b>Wind Pressure Loading</b> (10 second load) per ASTM E330	+1680 Pa (+35.09 psf)	0.01	0.23	0.01
	+2500 Pa (+52.20 psf)	0.00	0.05	0.00
	-1680 Pa (-35.09 psf)	0.04	0.28	0.02
	-2500 Pa (-52.20 psf)	0.13	0.01	0.04

**Note 1:** The results reported at  $\pm 1680$  Pa ( $\pm 35.09$  psf) are deflections under load. The results reported at  $\pm 2500$  Pa ( $\pm 52.20$  psf) are permanent deformations after loading.

**Note 2:** See Architectural Testing Sketch #1 for indicator locations.

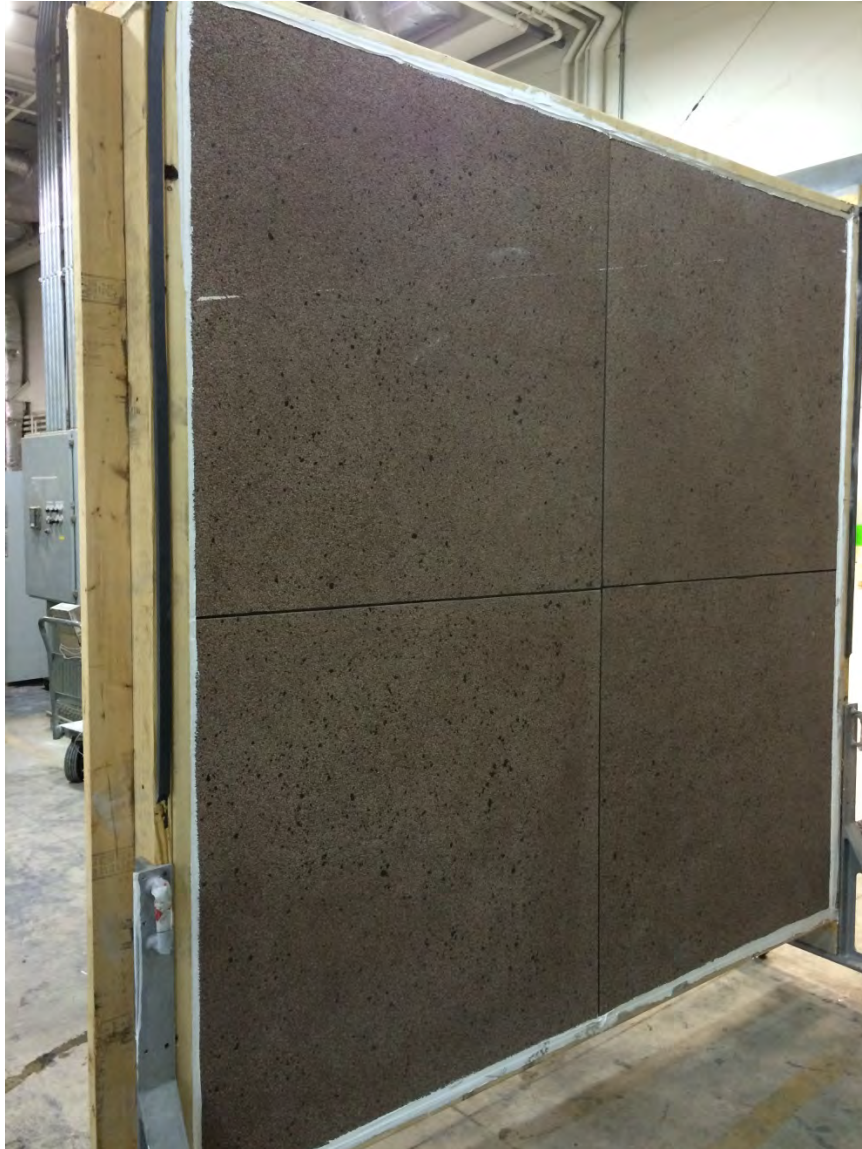
**Photo No. 1**

**Exterior of Test Specimen**

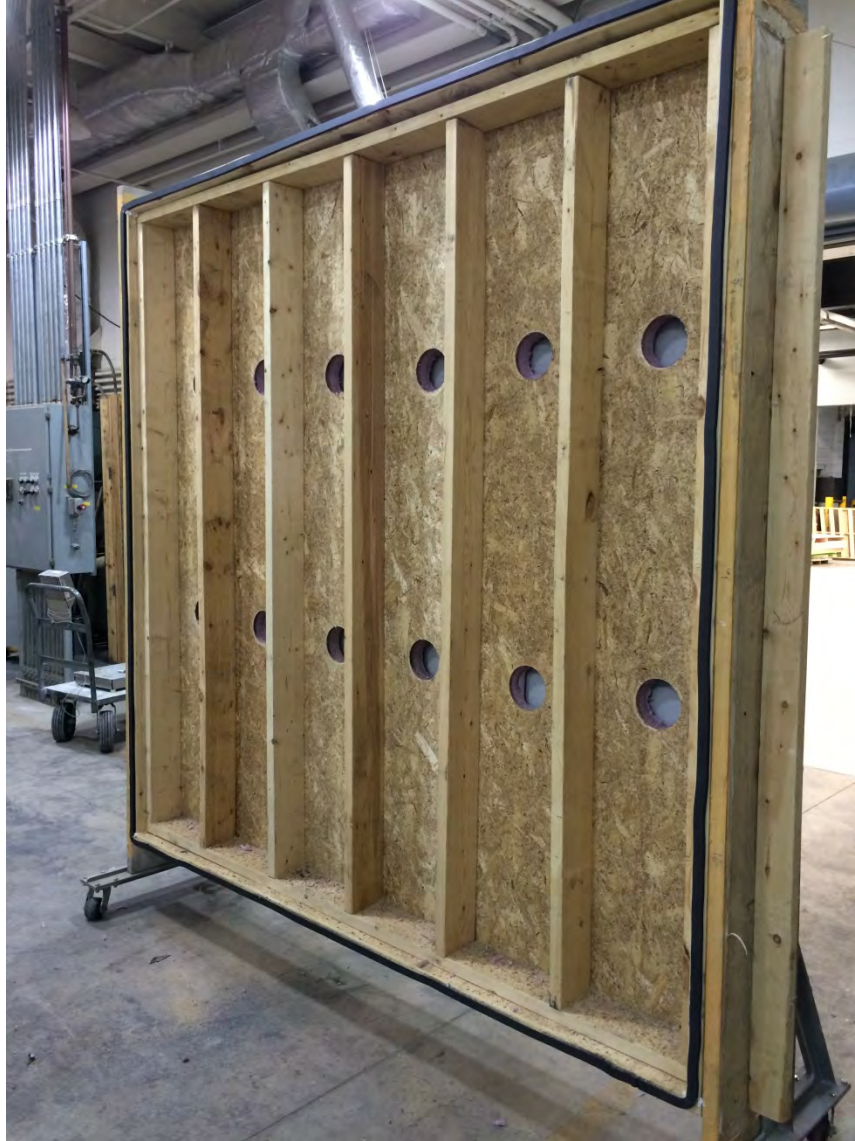
**Photo No. 2**

**Interior of test specimen**
